Manhole Inspection Summary

Manhole # S350__032MH

Insp Date: **1/24/08 9:09 AM**

Location Address: **w churchill st**

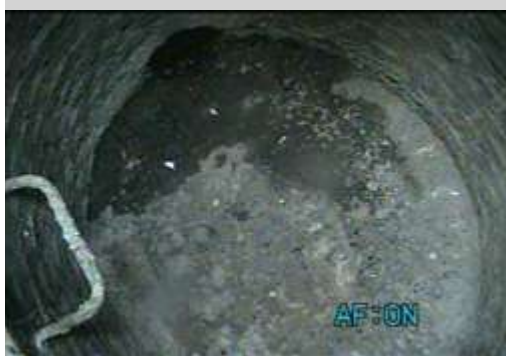
Defect 1

Condition: ☐ Sound ☐ Cracked ☐ Root Intrusion ☐ Deteriorated ☐ Leaks ☒ **Debris**

channel debris

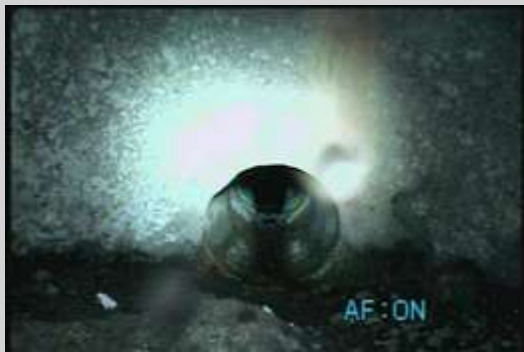
12 O'Clock Outflow

8 in. Circular Gravity Sewer
Pipe Out @ 12 O'Clock

Pipe Material: **Clay** ☐ Pipe Lined

Deposits: ☒ None ☐ Mud ☐ Sludge ☐ Debris ☐ Grease
